AIRCRAFT ACCIDENT REPORT

CRASH DURING LANDING
FEDERAL EXPRESS, INC.
MCDONNELL DOUGLAS MD-11, N611FE
NEWARK INTERNATIONAL AIRPORT
NEWARK, NEW JERSEY
JULY 31, 1997

NTSB/AAR-00/02

DCA97MA055

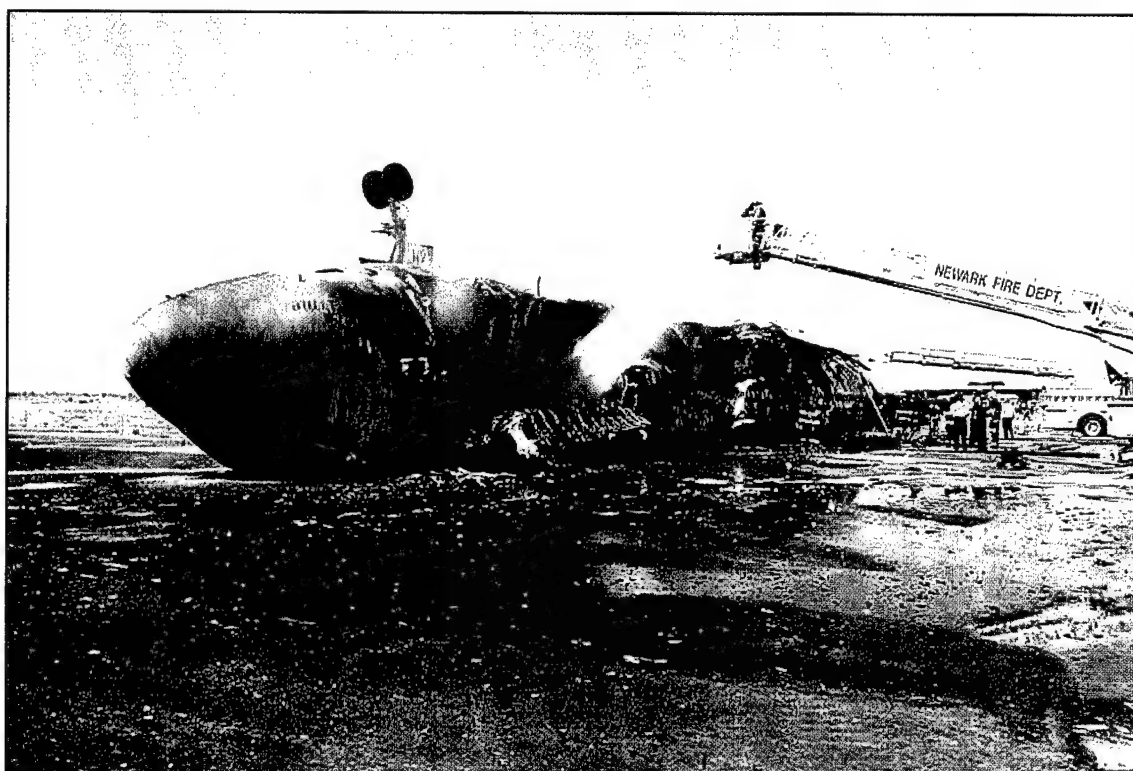
Figure 3. N611FE during the final portion of the firefighting effort.

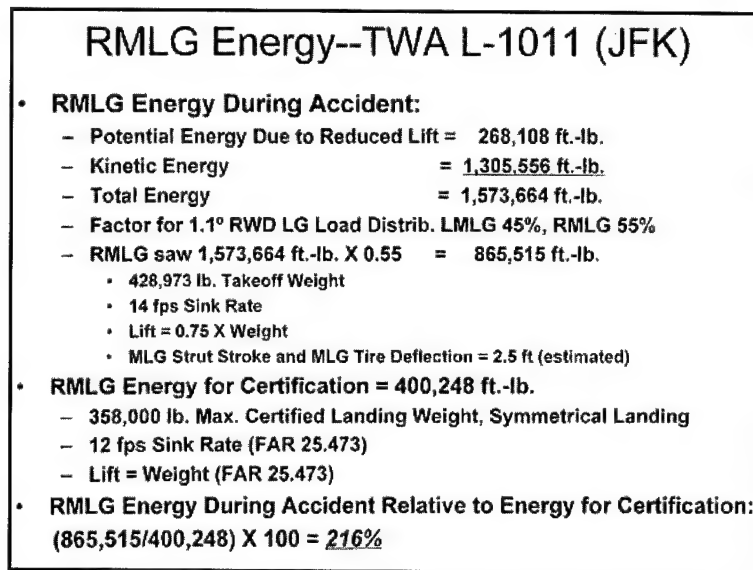
Figure 11 shows Boeing's calculations of the energy imparted to the right MLG in the L-1011 accident.

Figure 11. Boeing calculations of right MLG energy in the TWA L-1011 accident.

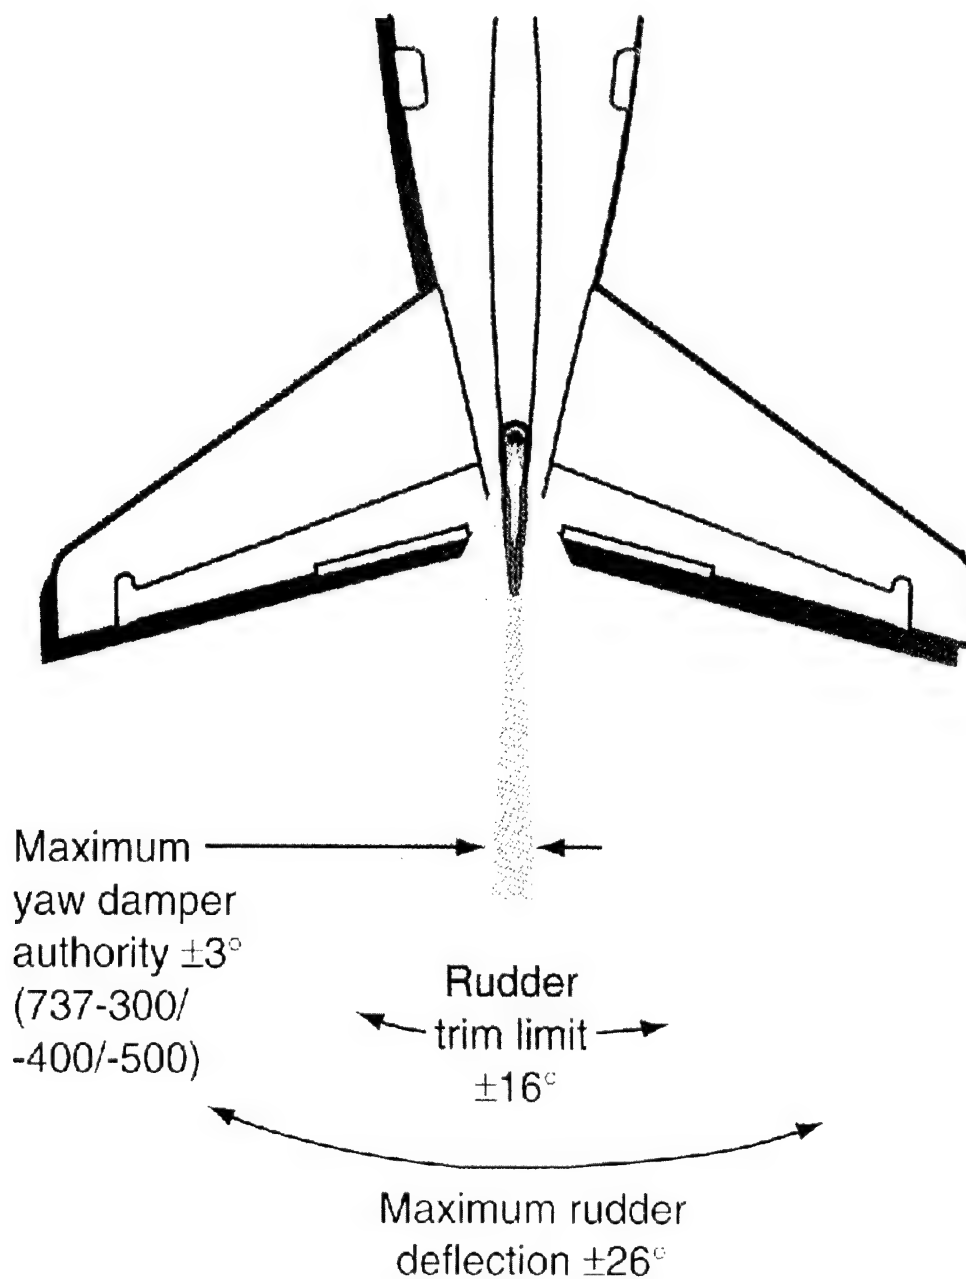
Note: The maximum 737 rudder deflection that the yaw damper can command is only a small portion of the total rudder travel. Yaw damper limits of the 737-100 and -200 can be 2, 3, or 4°, depending upon the installation.

Figure 9. Boeing 737-300, -400 and -500 rudder, rudder trim, and yaw damper authority limits.

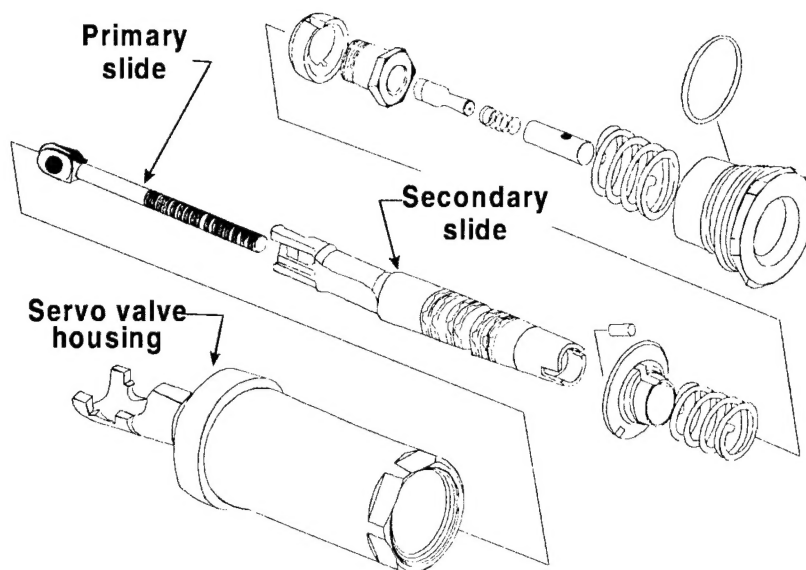
The 737 main PCU servo valve was designed by Boeing and is manufactured to Boeing specifications by Parker Hannifin Corporation. It is a dual-concentric tandem valve composed of a primary slide that moves within a secondary slide that, in turn, moves within the servo valve housing. The primary and secondary concentric slides are moved by primary and secondary internal summing levers, which translate inputs from the yaw damper⁵⁸ and/or the external input crank (which moves when a pilot steps on the rudder pedals) into axial movement of the slides. Figure 10 shows an expanded view of the servo valve.

Figure 10. Boeing 737 main rudder PCU servo valve.

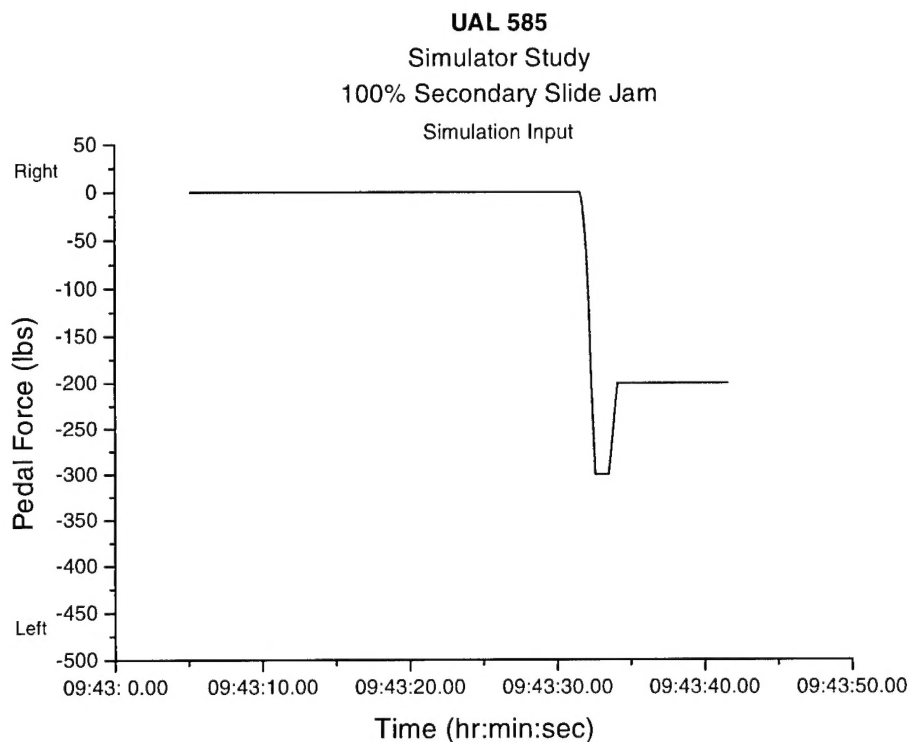
Figure 22a. Pilot rudder pedal force positions for United flight 585.
